Lessons learned from a disaster

Ian Nimmo & John Moscatelli, User Centered Design Services, LLC, USA, reflects on how learning from past experience has helped improve alarm management systems.

The incident

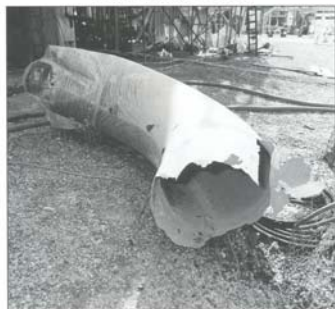
The Incident

Figure 2. The 30 inch flare line elbow bent and fell to the ground, releasing the hydrocarbon

of failures in management, equipment and control systems during the plant upset. These led to the release of about 20 t of flammable hydrocarbons from the outlet pipe of the flare knock out drum of the FCCU.

The incident was caused by flammable hydrocarbon liquid being continuously pumped into a process vessel that had its outlet closed. The only means of escape for this hydrocarbon once the vessel was full was through the pressure relief system and then to the flare line. The flare system was not designed to cope with this excursion from normal operation and failed at an outlet pipe. This released 20 t of a mixture of hydrocarbon liquid and vapor, which subsequently exploded.

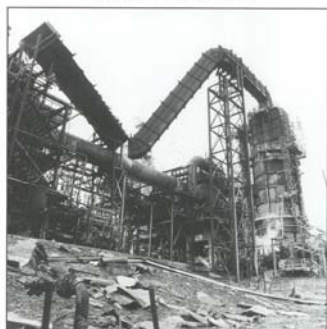
The Incident

The released hydrocarbons formed a drifting cloud of vapor and droplets that found a source of ignition approximately 125 yards from the flare drum. The force of the consequent explosion was calculated to be the equivalent of at least 4 t of high explosive.

This caused a major hydrocarbon fire at the flare drum outlet and a number of secondary fires. The site suffered severe damage to process plant, buildings and storage tanks. 26 people sustained injuries onsite, none serious. Rebuilding the damaged refinery cost an estimated US\$ 75 million¹.

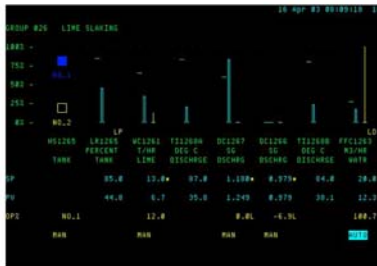
Typical Group Display

Unfortunately, this need was not met. There were no displays providing an overview with an appropriate time scale on the FCCU. Therefore, it was difficult to obtain a complete picture of the whole or large sections of the process.

- The operating graphics on the FCCU contained limited amounts of process data per graphic, and did not make use of color and intensity to highlight process data.
- Some graphics contained details of the internal structure of plant items. However, displaying the structure of plant items is only useful if measurements or derived information (e.g. pressure, flow, temperature) are also displayed to give the operator information relevant to the plant status.
- At times the text was unnecessary in the FCCU graphics. Text takes up large amounts of space on a graphic and there were instances where the same information could have been better indicated by color change.
